NATIONAL TRANSPORTATION SAFETY BOARD

SAFETY RECOMMENDATIONS
ADOPTED DURING THE MONTH OF JULY, 1999

Safety Recommendation

In reply refer to: A-99-51 through -54

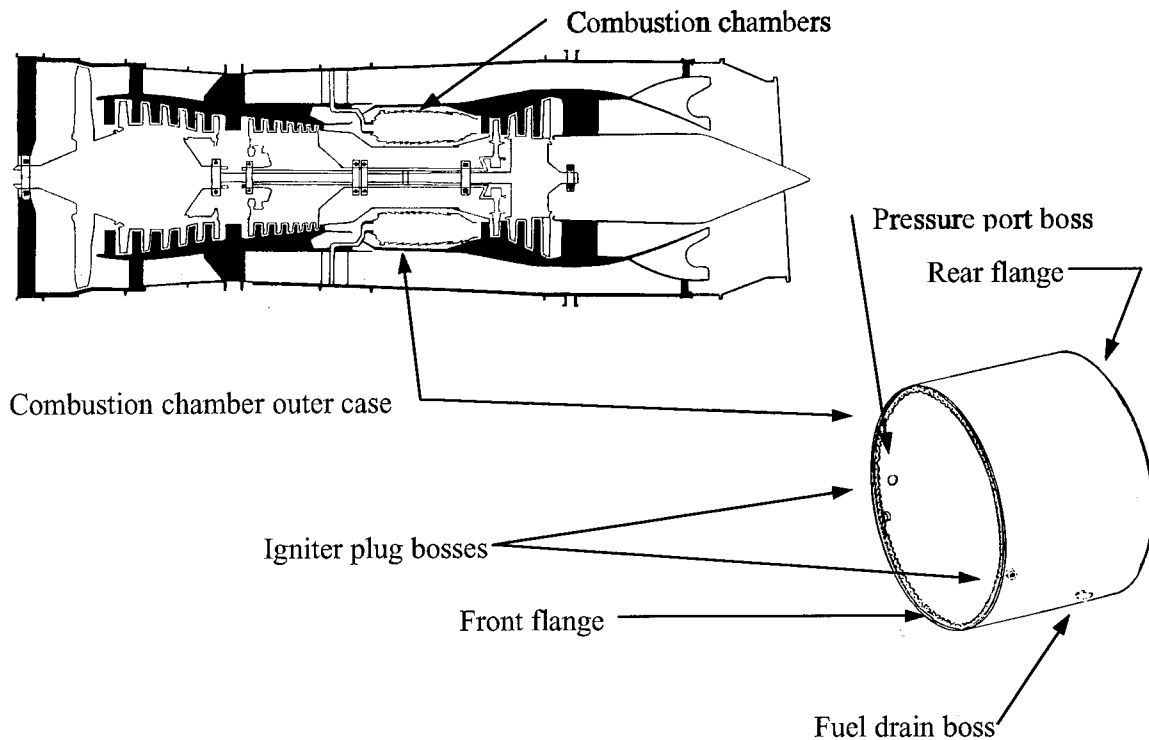
The CCOC is a barrel-shaped structure that houses the combustion chambers and contains four circular-shaped bosses, mounted on which are two igniter plugs, a pressure port, and a fuel drain (see figure 1). The ruptured CCOC was assembled in six pieces: the front flange³ and body, the four bosses, and the rear flange. The front flange and body of the case and the four bosses were made of AMS [Aerospace Material Specification] 5613 410 stainless steel,⁴ and all of the

Figure 1. JT8D-200 engine cross section showing the location of the CCOC, and an enlarged view of the CCOC showing the location of the bosses and the case's front and rear flanges.

The ruptured CCOC was examined at the National Transportation Safety Board's materials laboratory. This examination revealed a fatigue fracture that had multiple origins along the weld on the exterior side of the fuel drain boss. The fracture had propagated about 150° around the boss and then axially, about 1½ inches forward and ½ inch rearward. The fatigue striations indicated that the crack had existed for approximately 1,340 cycles before the CCOC ruptured. The fracture originated from a mechanically thinned area of the boss' flange that had grinding marks consistent with previous work. The measured thickness of the boss flange adjacent to the fatigue fracture was 0.080 inch; however, the fuel drain boss' engineering drawing required a thickness of 0.099 to 0.109 inch.

Require, as an interim action, Pratt & Whitney to identify all JT8D-1 through -17AR and JT8D-200 engine combustion chamber outer cases (CCOC) that had boss welds reworked during manufacture; require repetitive on-wing inspections of those CCOCs for boss weld cracks at intervals appropriately less than 1,340 cycles in service; and, if cracks are found, require the removal of those engines from service for replacement of the CCOC. Periodic inspections should continue until a one-piece, integral boss CCOC is installed. (A-99-52)

Require, as an interim action for those Pratt & Whitney JT8D-200 engine combustion chamber outer cases (CCOC) that did not have the boss welds reworked during manufacture, repetitive on-wing inspections of the bosses at appropriate intervals for cracks in the welds and, if cracks are found, require the removal of those engines from service for replacement of the CCOC. Periodic inspections should continue until a one-piece, integral boss CCOC is installed. (A-99-53)

Require a one-time inspection to identify any Pratt & Whitney JT8D-1 through -17AR and JT8D-200 combustion chamber outer cases (CCOC) with nonmagnetic bosses. If such bosses are found, require the removal of those engines from service for replacement of the CCOC with a one-piece, integral boss CCOC. (A-99-54)
